# PROPOSED REMEDIAL ACTION PLAN

K - Dangman Park MGP  
Operable Unit Number 01: Remedial Program  
Manufactured Gas Plant Program  
Brooklyn, Kings County  
Site No. 224047  
February 2020

Prepared by  
Division of Environmental Remediation  
New York State Department of Environmental Conservation

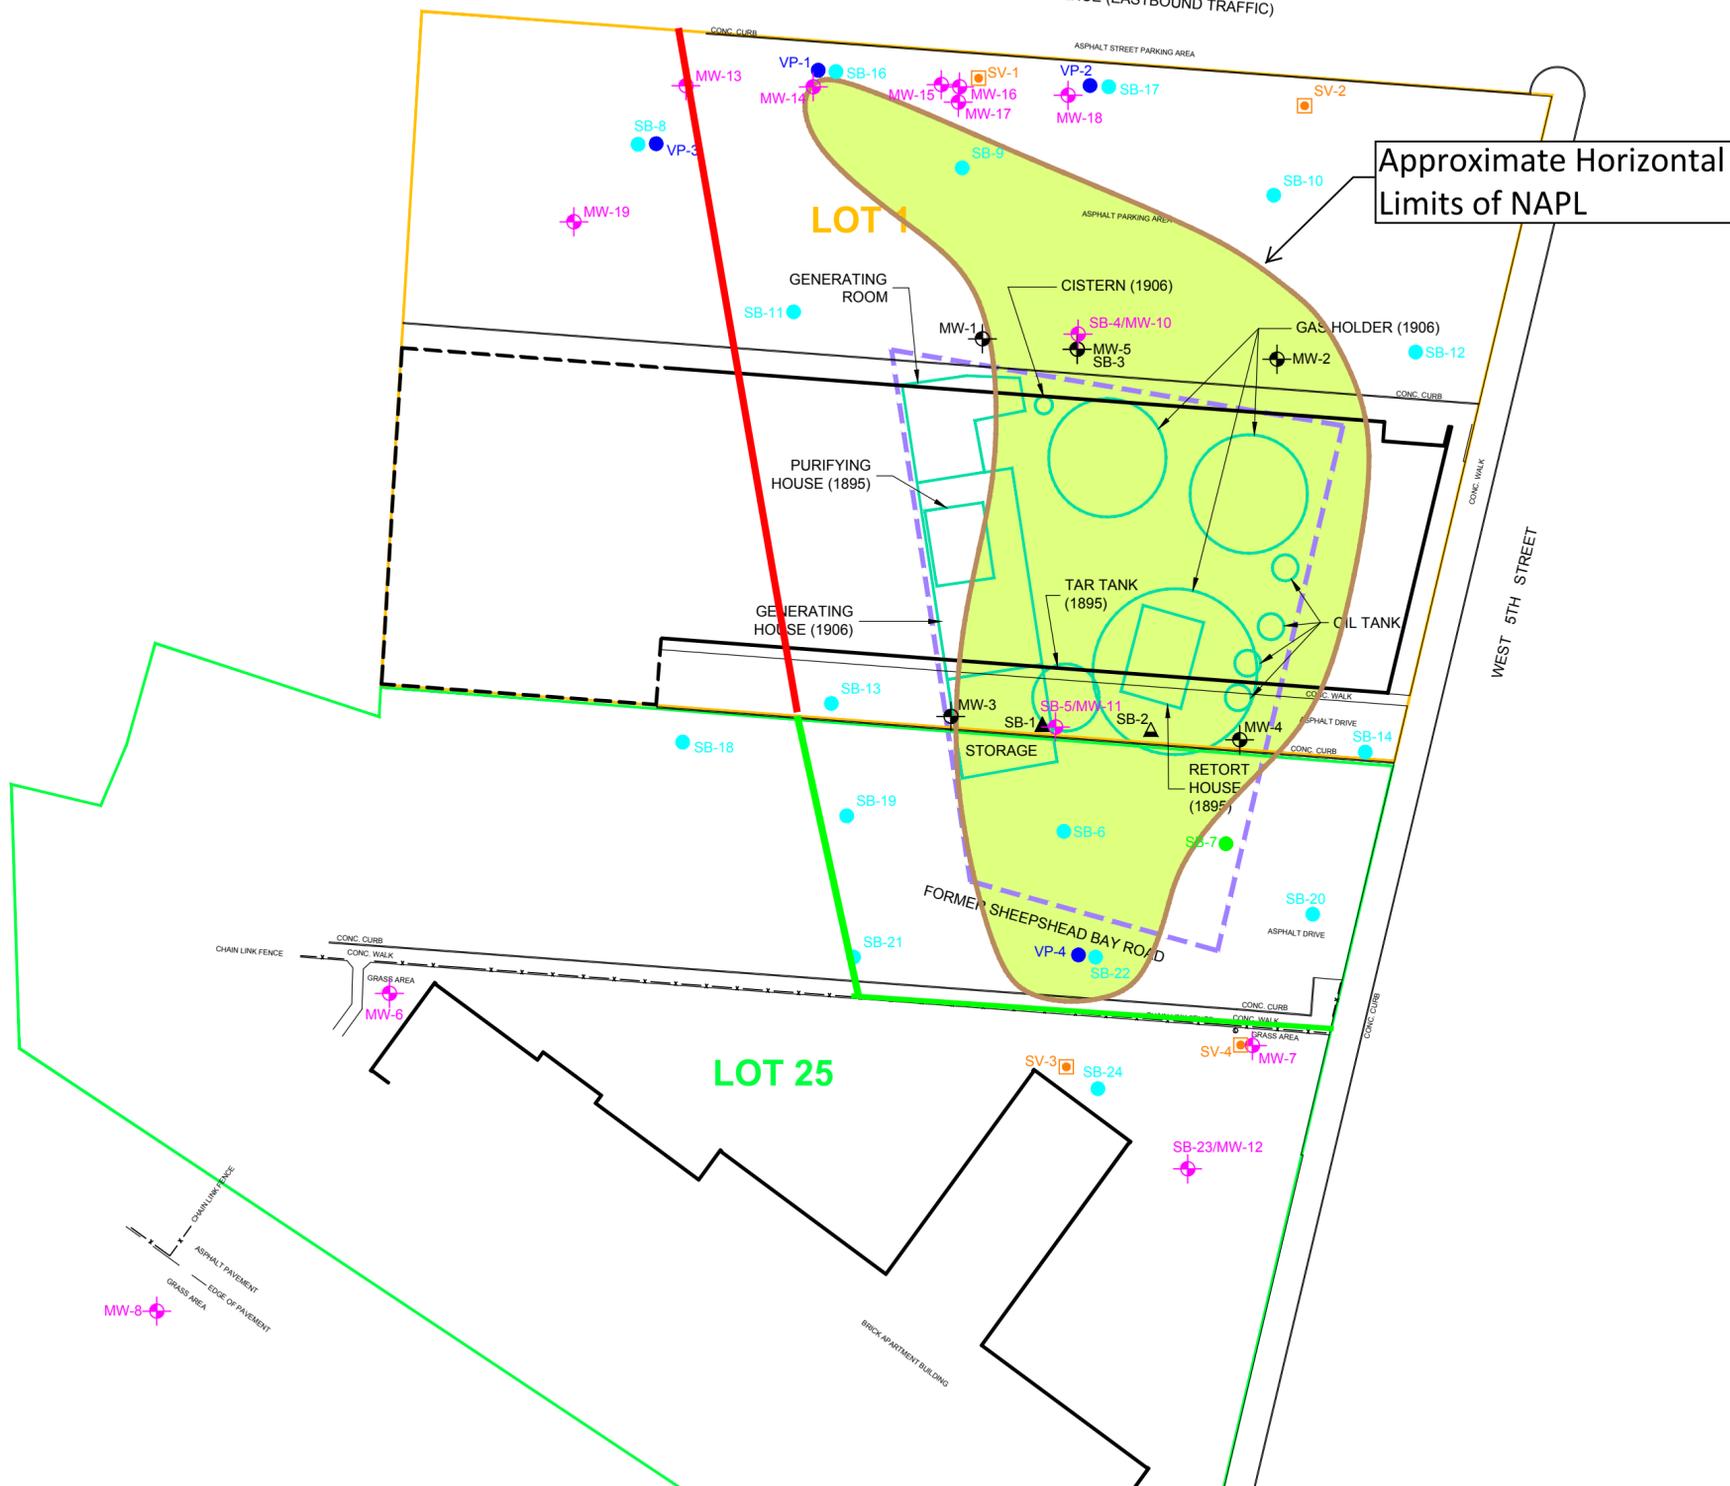
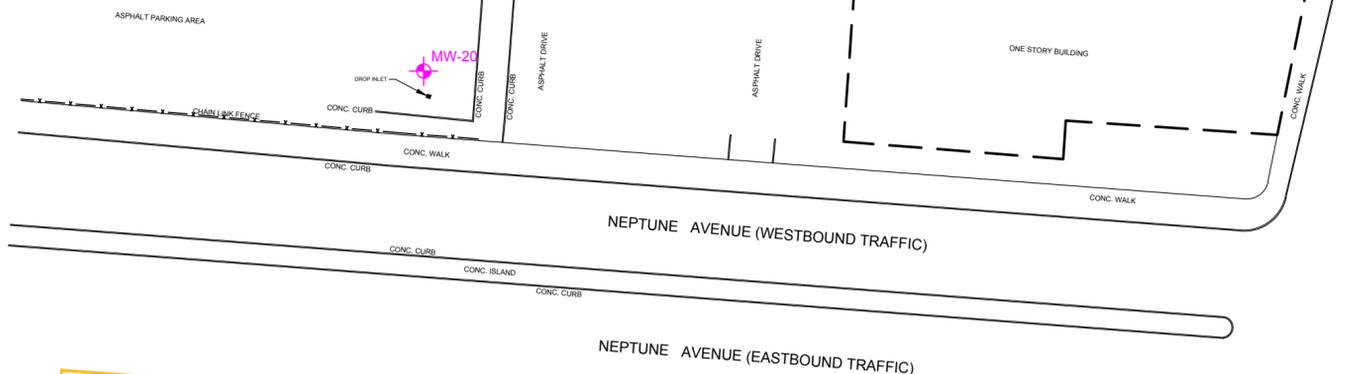
Approximate Horizontal Limits of NAPL

The Waste and Source areas identified at the site were observed in areas corresponding with the footprint of the former MGP and in areas directly adjacent to those operations. Data collected during the remedial investigation indicates that the primary contaminants of concern include MGP related coal tar and its associated compounds (PAHs and BTEX). Soil saturated with coal tar was observed near and/or within historic structures including the former gas holders, the cistern and the tar tank. Figure 5 shows the limits of the area where source material was observed during the RI. As discussed in Section 6.2, IRMs were implemented in 2017 to address the source areas that were accessible within the top fifteen feet from the ground surface. Contamination was removed from several discrete areas where coal tar saturated soil was observed in the top 15 feet, and in-situ oxidation was utilized to treat a larger area of source material that remained. See Figures 3 and 4 for IRM areas.
